ENVIRONMENTAL PRIORITIES INITIATIVE VISUAL SITE INSPECTION REPORT FOR

SUN CHEMICAL CORPORATION NEWARK, NEW JERSEY EPA ID NO. NJD002458842

# VISUAL SITE INSPECTION REPORT

### SUN CHEMICAL CORPORATION NEWARK, NEW JERSEY EPA ID NO. NJD002458842

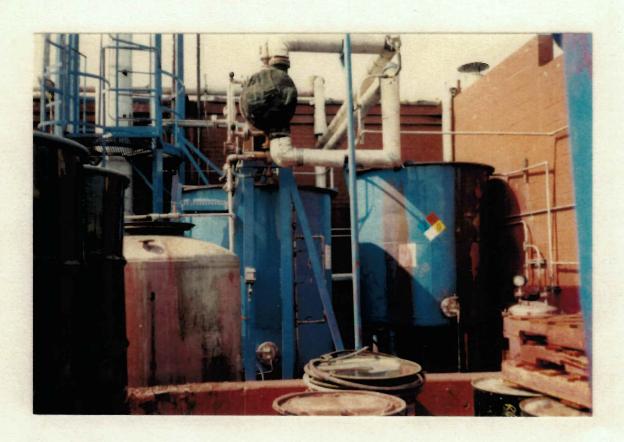
Photograph No. 2

View facing north of the tanks at the Distillation Unit (SWMU 4). The blue tank on stilts to the far right is the Distillation Feed Tank (SWMU 3). The blue tank in the middle of the photograph contains the reclaimed methanol. The silver tank in the left foreground is Distillation Bottoms Tank (SWMU 5). The two drums to the left of the picture are empty. The black drums pictured are used for product packaging.

This unit is located north of the main administration building and west of the Distillation Feed Tank (SWMU 3). The unit is constructed of stainless steel, has a capacity of 330 gallons, and is approximately 30 feet high. The unit receives process effluent from the Distillation Feed Tank which contains water, methanol, and phosphoric acid. The distillation process involves the heating of the effluent and the separation of methanol from phosphoric acid and water. The "tops" of the distillation

This unit is located northeast of the administration building and is adjacent to the Distillation Unit (SWMU 4). The tank is constructed of carbon steel and has a capacity of 700 gallons. The tank receives phosphoric acid wastewater from the Distillation Unit which is then pumped to the Wastewater Collection and Treatment System (SWMU 6) where it is neutralized prior to discharge to the POTW. The unit is located in the same concrete containment structure as the Distillation Unit. The containment structure is constructed of three feet high walls with a concrete base. The tank was noted to be in good condition and no evidence of release was noted at the time of the VSI. According to facility representatives, the tank has no reported history of release.

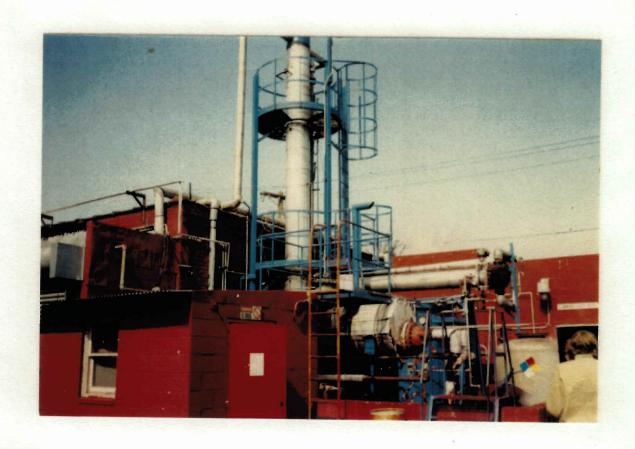
Photograph No. 3

View to the north of the Distillation Unit (SWMU 4). The reboiler is steam-jacketed. The Distillation Bottoms Tank (SWMU 5) is visible to the right.

The unit is located north of the main administration building and east of the Distillation Unit (SWMU 4). The unit is a 1,000-gallon tank constructed of stainless steel and supported on steel legs. Process effluent from the Hazardous Waste Storage Tank (SWMU 2) is held in this tank and pumped to the Distillation Unit (SWMU 4) where methanol is separated from phosphoric acid and water. The unit is located in the same concrete containment system as the Distillation Unit. The containment system is comprised of a concrete base and three feet high concrete walls. The tank was noted to be in good condition and no evidence of release was noted at the time of the VSI. According to facility representatives, the tank has no reported history of release.

The distillation unit is located within a concrete containment system consisting of a concrete base and three foot high walls. The Distillation Feed Tank (SWMU 3), the recovered methanol tank, and the Still Bottoms Tank (SWMU 5) are also located within this containment system. The unit operates under an air permit from the NJDEPE. The unit and the containment system appeared to be in good condition at the time of the VSI. According to facility representatives, the tank has no reported history of release.

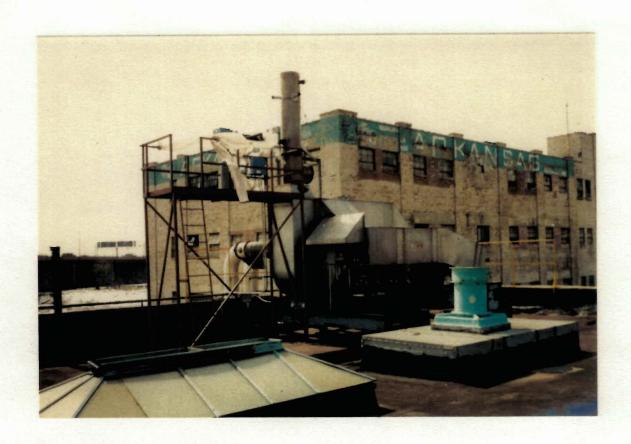
## Photograph No. 6

View facing west of the Catalytic Incinerator (SWMU 7) on top of the main processing building. The large brick building in the background is part of the old industrial complex located in the area.

The incinerator is located on the roof of the two story main processing building. The incinerator is approximately 20-feet long, 12-feet high, and 5-feet wide. It is constructed of welded stainless steel and has a 6 feet tall steel stack. The incinerator receives vapors from the ovens used to dry the pigment after it has been removed from the filter presses. Facility representatives indicated that the emissions from the ovens are predominantly water vapor. The unit is supported on a steel beam structure. The unit is permitted under a NJDEPE permit and appeared to be in good condition at the time of the VSI.

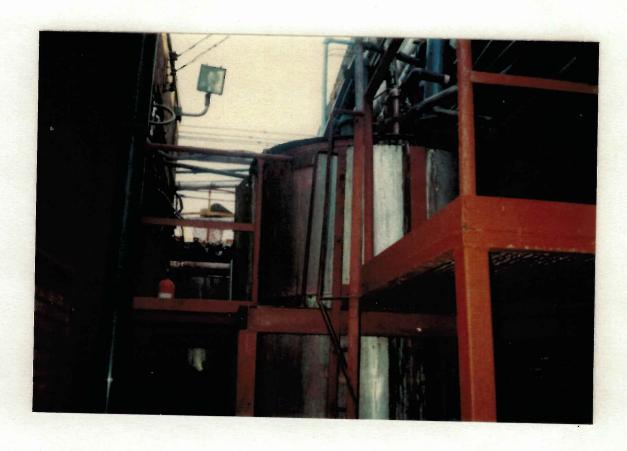
Photograph No. 7

View facing northwest of one of the two neutralizing tanks which are part of the Wastewater Collection and Treatment System (SWMU 6).

directly to the two neutralization tanks. The pH of the wastewater is monitored and adjusted in the neutralization tanks. A liquid caustic is used to neutralize the acidic wastewaters prior to discharge to the Passaic Valley Authority (PVA) sewer system. The discharge from the tanks to the sewer system is permitted by the PVA. Minor exterior corrosion of the neutralization tanks and underlying concrete was noted at the time of the VSI. However, there was no evidence of a release. According to facility representatives, the unit has no reported history of release.

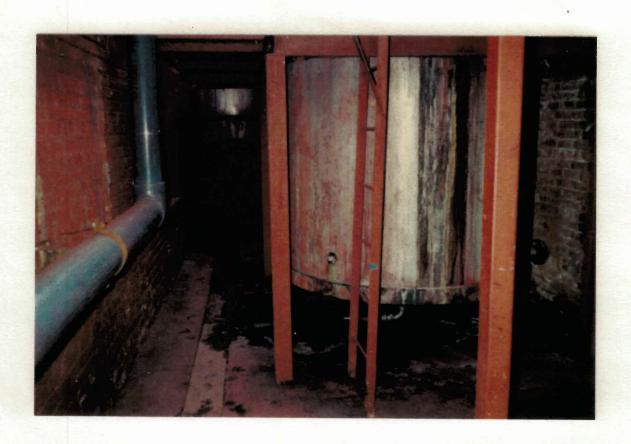
## Photograph No. 8

View of the base of one of the neutralization tanks, part of the Wastewater Collection and Treatment System (SWMU 6). Note cagelike support structure for tanks and exterior staining of tank and stained concrete.
